THE CROSS CANYON CORRIDOR HISTORIC DISTRICT  
IN GRAND CANYON NATIONAL PARK:  
A MODEL FOR HISTORIC PRESERVATION

Submitted in Partial Fulfillment  
of the Requirements for the Degree of  
Master of Arts in Anthropology  
Northern Arizona University

August 1986

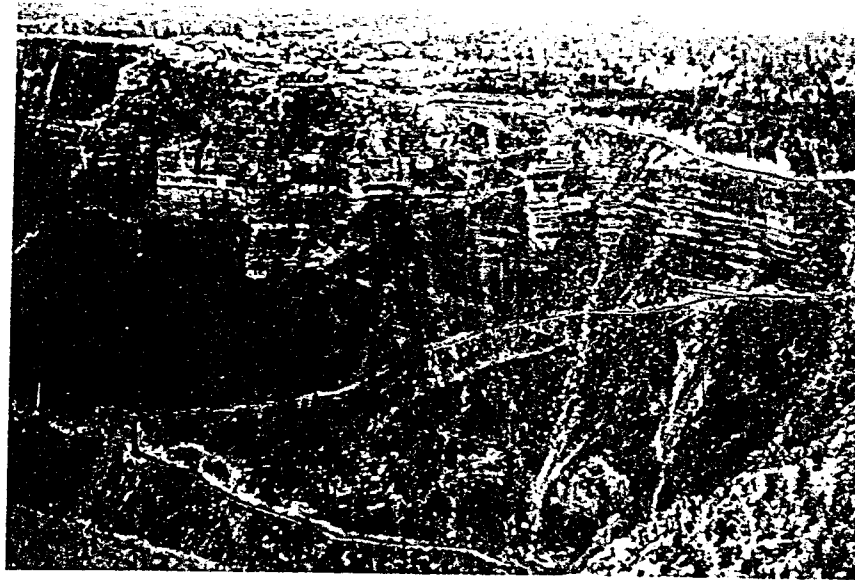
Figure 3

The Bright Angel Trailhead After Reconstruction, 1932

The following October, work began on the trail above Indian Gardens. The difficult Jacobs Ladder section through the Redwall Limestone had to be blasted through solid rock walls to ease grades. The first tunnel near the trailhead had to be widened so that the trail could be routed through it on longer and gentler switchbacks. The original trail did not go through the tunnel, but descended in steep switchbacks east of it. (Figure 3 shows the old and new trail sections at the trailhead.) The tunnel, located in

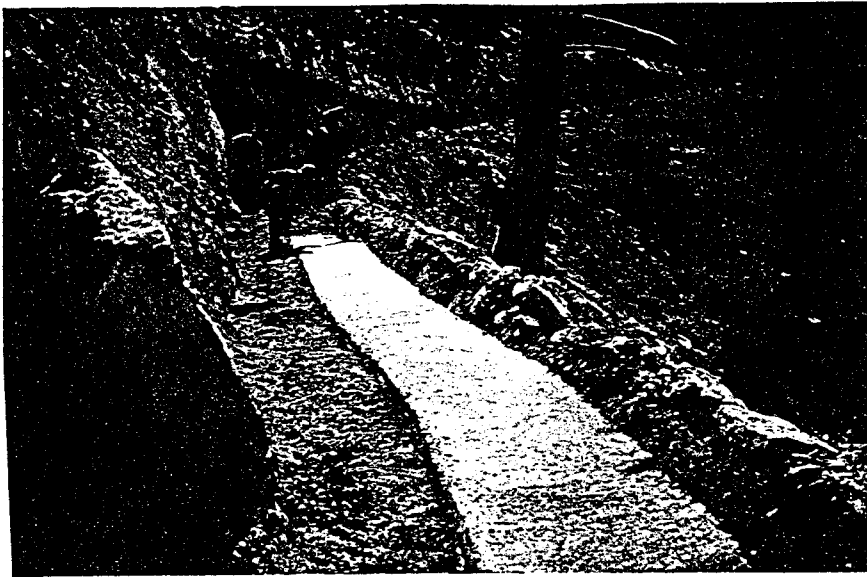
Figure 4

Bright Angel Trail Oiling, September, 1932

In the fall of 1932, the Park initiated a program of trail oiling in an effort to keep down the ubiquitous red dust (Underhill 1932: 2). The process was laborious. Crews struggled with an unwieldy "Cetrac trail oiler" down nearly two miles of trail (Figures 4 and 5). The machine could not be transported past that point, so workers had to apply the oil by hand with a spray nozzle from there to Pipe Creek, and mules packed in the oil (Carrel 1933: 1).

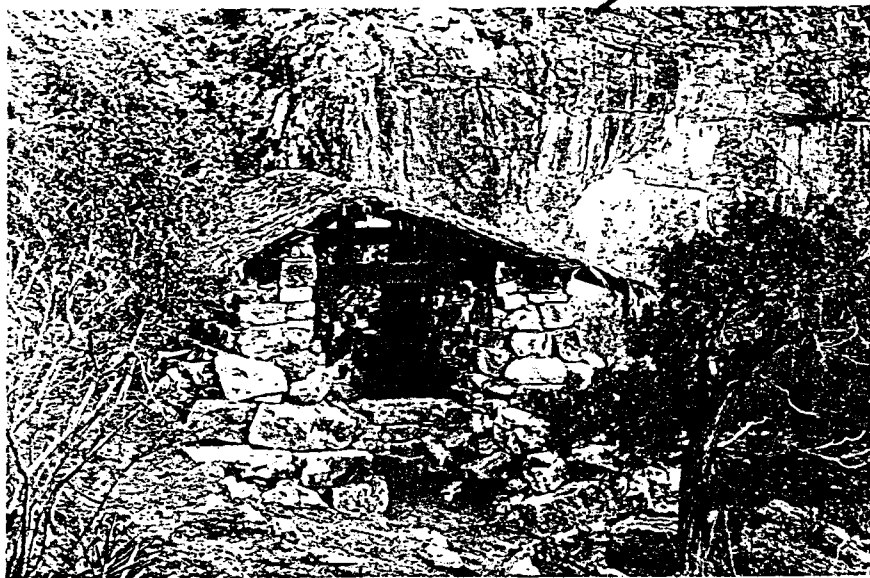
Figure 6

Three-Mile House Trailside Shelter, 1936

CCC crews constructed four hiker's shelters along the Bright Angel Trail between 1935 and 1937, in the following order: Three-Mile House (Figure 6) (1935), Mile-and-a-Half-House (Figure 7) (1936), River Rest House (Figure 8) (1936), and Indian Gardens Rest House (1937) (Kuehl 1935a, 1935b, Tillotson 1936). The River Rest House, which contained naturalist and geological exhibits and a telephone, burned in 1956. The rock walls remained intact and the NPS soon replaced the wooden superstructure exactly as the original (1949 building inspection form).

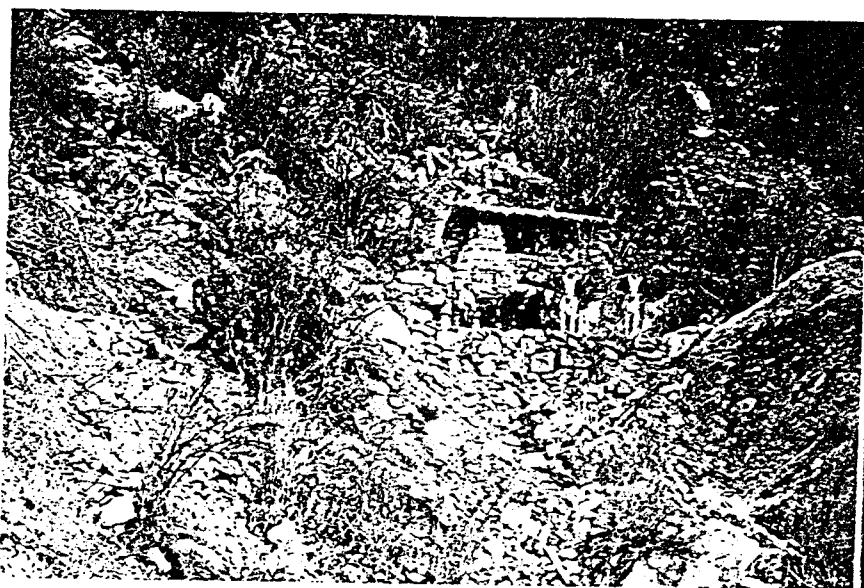
Figure 7

Mile-and-a-Half Trailside Shelter, 1936

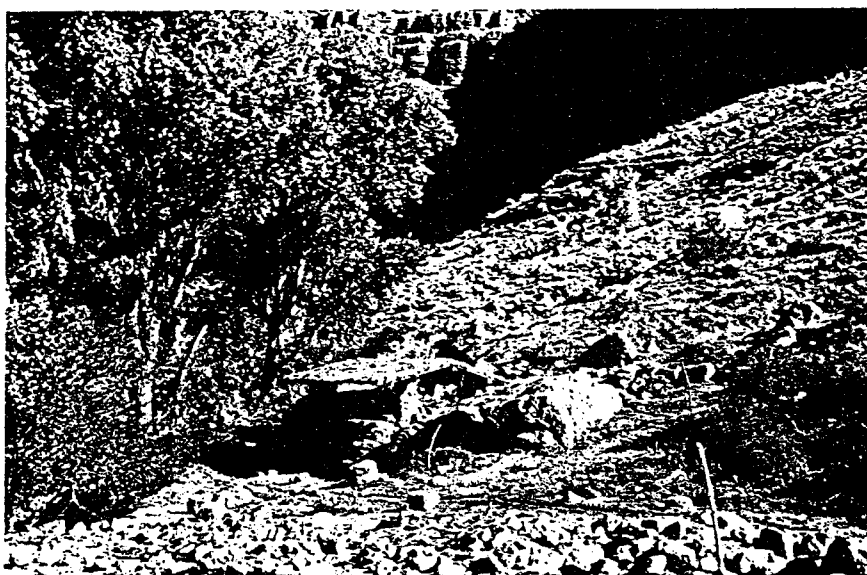
Figure 14

Indian Gardens Trailside Shelter, 1937

In 1937, CCC crews constructed two more structures at Indian Gardens: the trailside shelter (#143) (Figure 14) and

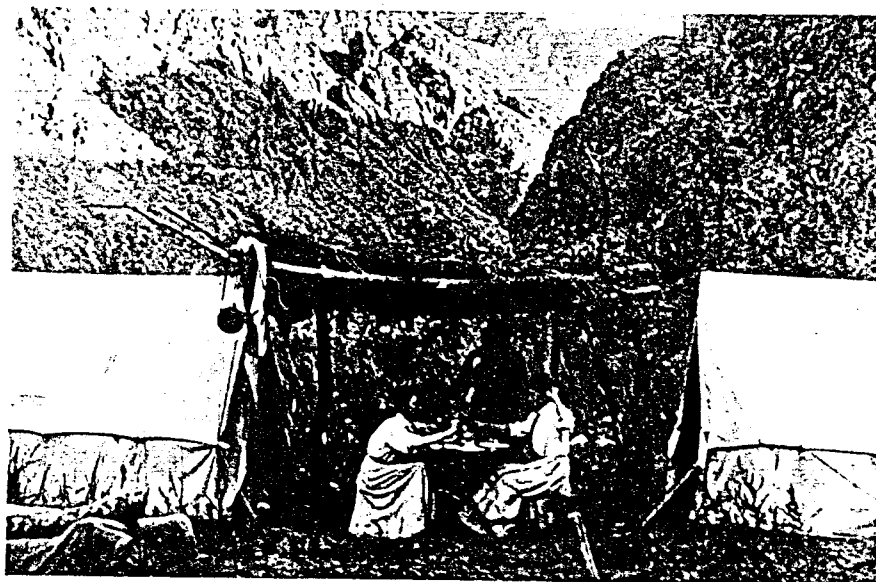
Figure 18  
Rust Camp, ca. 1907

He planted cottonwood and fruit trees, watered by an irrigation system, and erected several tents, temporary buildings, and ramadas for overnight guests (Figure 18) (Abbott 1978: 10). Rust apparently did not operate the camp for many years, because when Theodore Roosevelt stayed overnight on his way to a North Rim cougar hunt in July 1913 he found the area deserted (Roosevelt 1978: 194). With Rust gone, the place became known as "Roosevelt Camp".

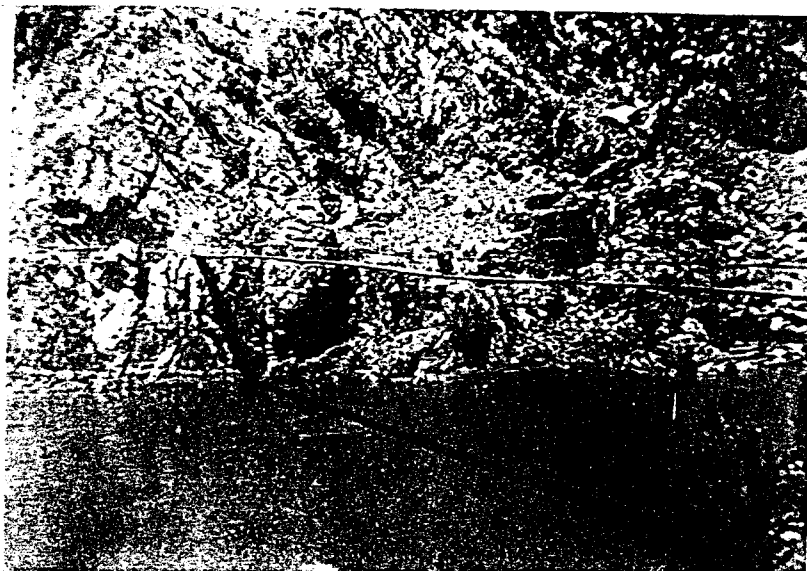
Figure 19  
First Colorado River Suspension Bridge, ca. 1922

By 1915, the tramway belonged "to Ex-Governor Wooley of Salt Lake City and [was] known as the Wooley Tramway" (Letter: Reaburn to Mather March 29, 1921). This likely refers to Rust's father-in-law Dee Wooley. The tramway remained in use until the Park Service built a new swinging suspension bridge (Figure 19) in 1921. The present rigid

Kaibab Suspension Bridge replaced the swinging bridge in 1928. The 1921 suspension bridge made tourist travel even easier, and paved the way for a unique dude ranch to cater to their needs.

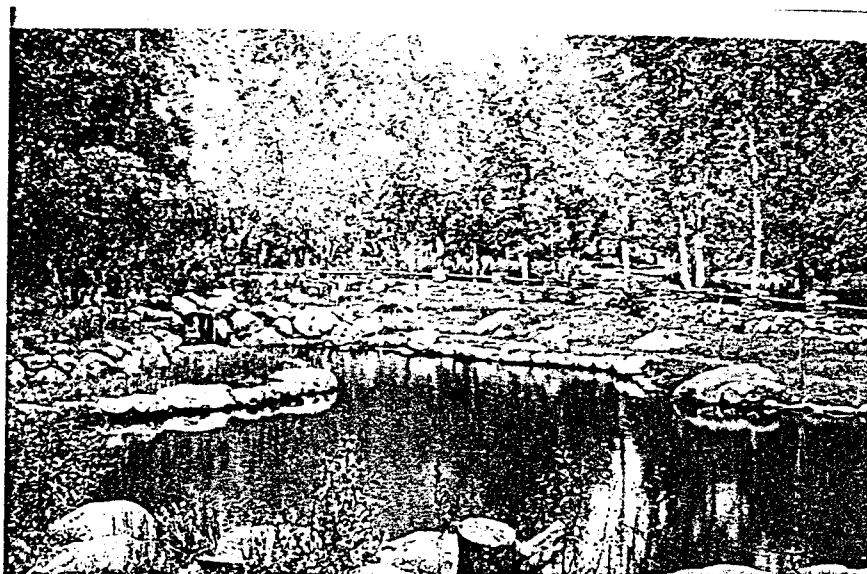
Figure 24

Finished Swimming Pool, 1936, Facing North

The CCC built a swimming pool north of the recreation building in 1934. Located in a flood plain filled with huge boulders, they excavated the pool by hand; a massive undertaking indeed (Figure 23). The waters of Bright Angel Creek, cascading over a small waterfall, fed the pool (Langley 1934: 2). The CCC enrollees themselves reaped the benefits of the finished pool, and it was a Phantom Ranch centerpiece for many years (Figures 24 and 25). With increasingly heavy use

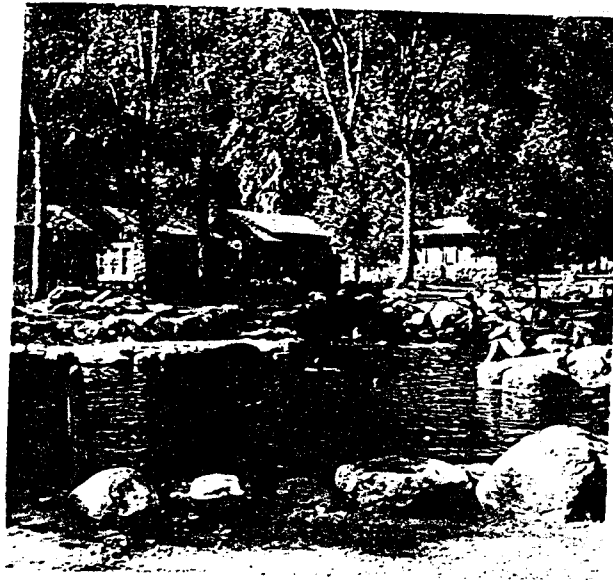
Figure 25

The Phantom Ranch Pool, ca. 1961. Note Cabins in Rear:  
1928 Cabins Left, 1922 Cabin (#891) Right

through the 1960s, the pool became a maintenance and health problem. In 1972, the National Park Service permitted the Fred Harvey Company to fill it in. Many items were reportedly thrown in, including hand carved doors from the recreation hall, a pool table, a piano, old oil burning stoves once used to heat the cabins, campground grills, and items from the old blacksmith shop (Abbott 1978: 20). The area may be a rich field for archaeological endeavors.

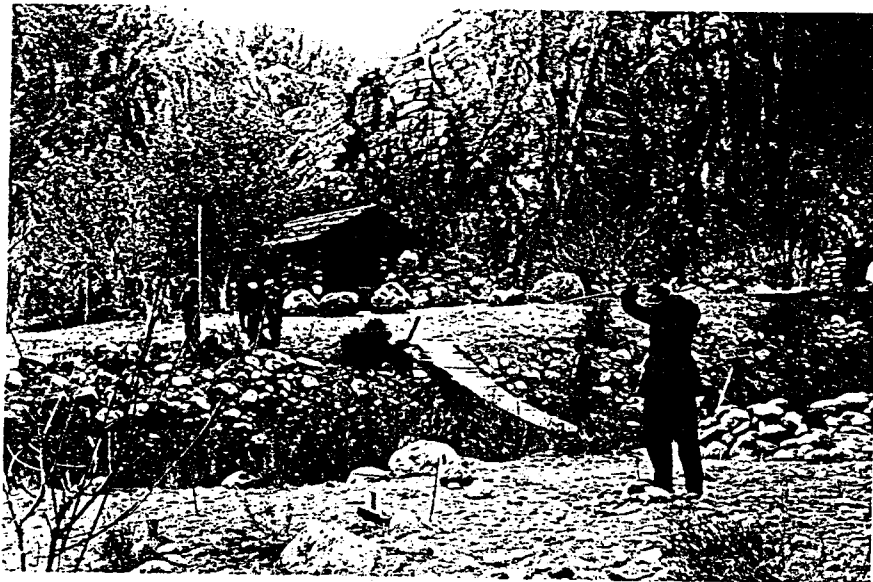
Figure 29

The Rock House, 1936. The CCC Crew is Surveying the Location for the Rock House Bridge

Eakin Dec. 19, 1925). In that same year, NPS erected their first permanent structure nearby, a single room residence known as the Rock House (#154, Figure 29) (Building Inspection Form: 1943).

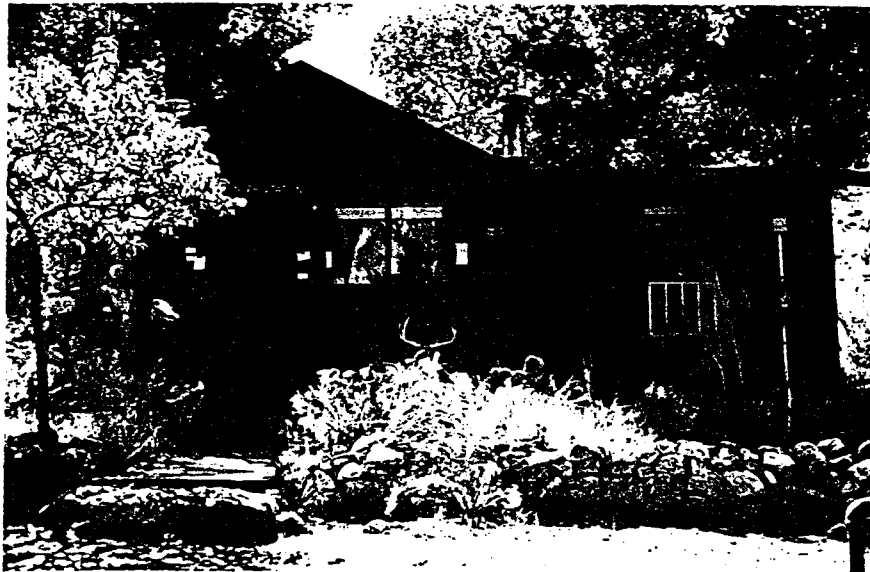
Figure 34

Indian Gardens Ranger Station, Facing South, 1985.  
The Recent Addition is to the Right.

These examples illustrate the detriment that improperly designed additions and modifications can have on the character of a historic district. These functional structures are not necessarily poorly designed, they are simply incompatible with the existing architectural setting. It is not difficult to design new structures that are compatible with the old, but the designer/architect must be sensitive to those design features which give the historic district its overall architectural unity.

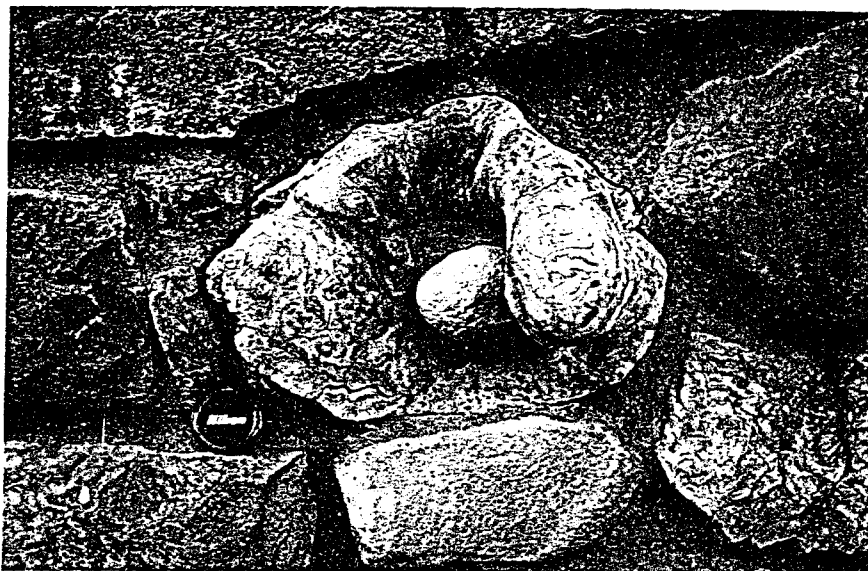
Figure 40

Wooden "Baseball Mitt" in the Wall of the Dining Hall
